September 2012

# **MAINTENANCE OF EXTERIOR JOINERY**

## **A SITE INSPECTION REPORT**

### **Building X, Reading**

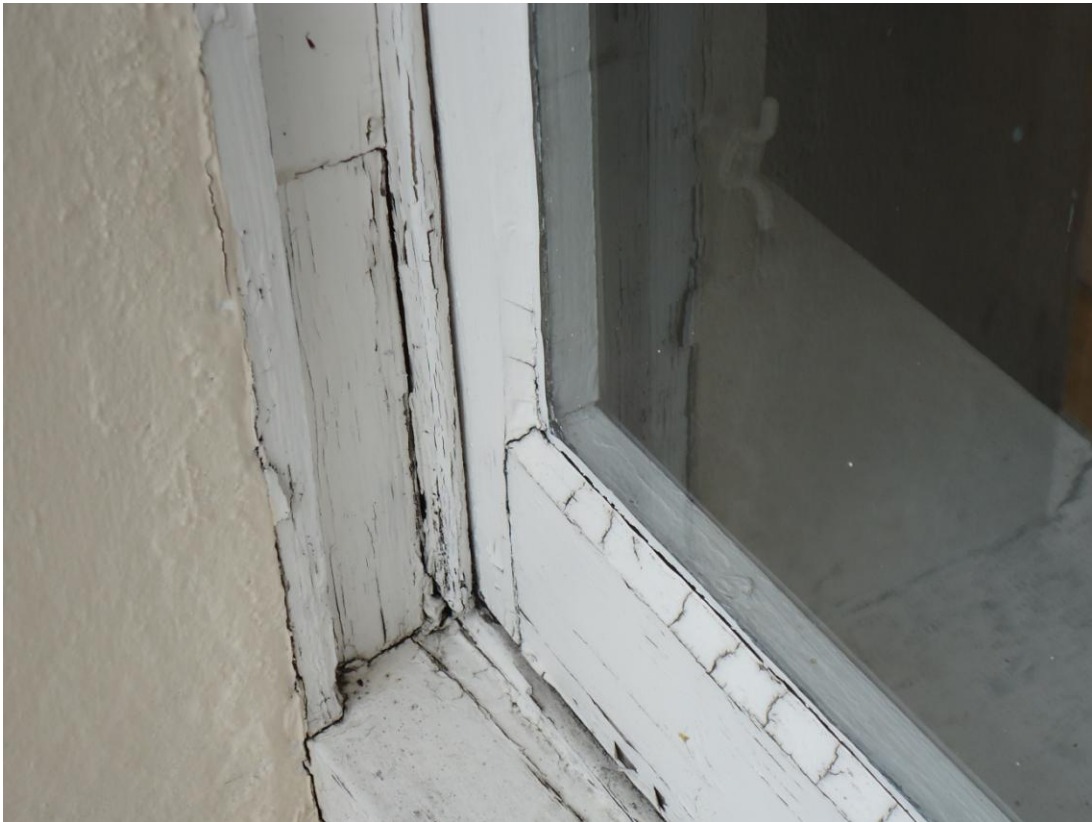
Example of failed putty, open joints and deteriorating paint

Renew existing failed putty/mastic using Repair Care Dry Seal in full accordance with the appropriate section of Working Method PG2.

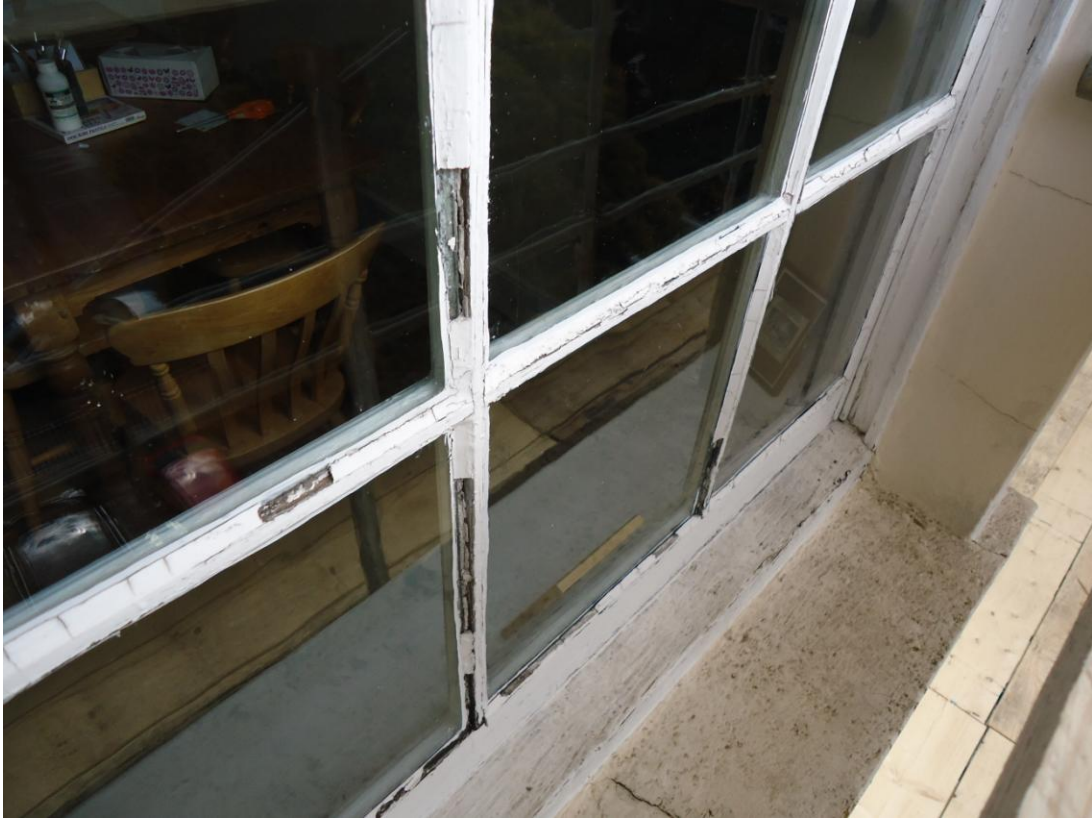
Example of failed putty lines

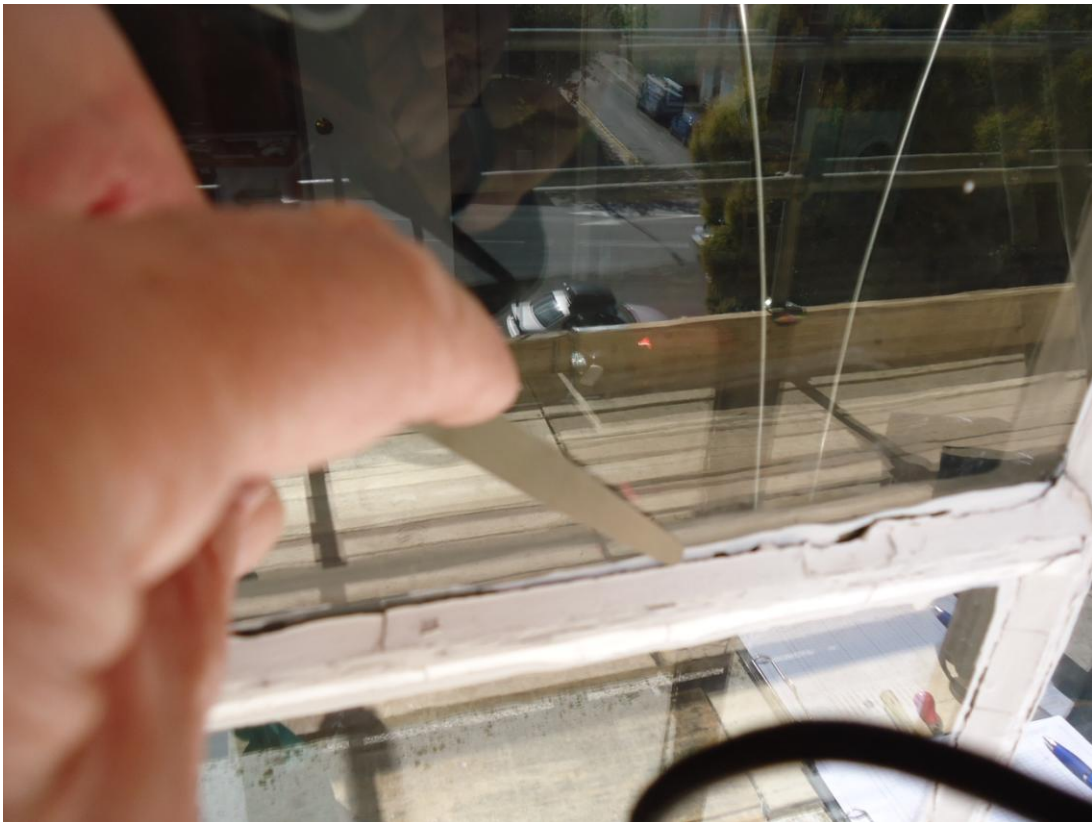
Gap between glass and putty allowing moisture ingress

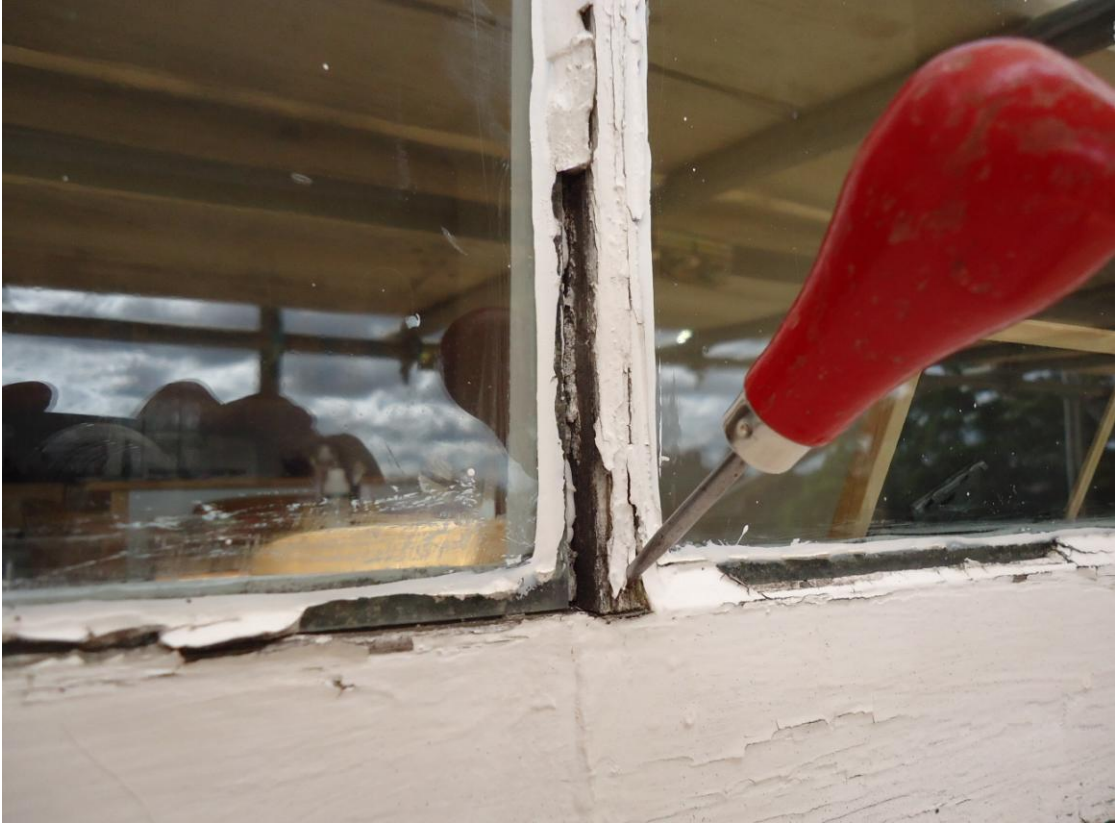
Decay to glazing bar and failed putty

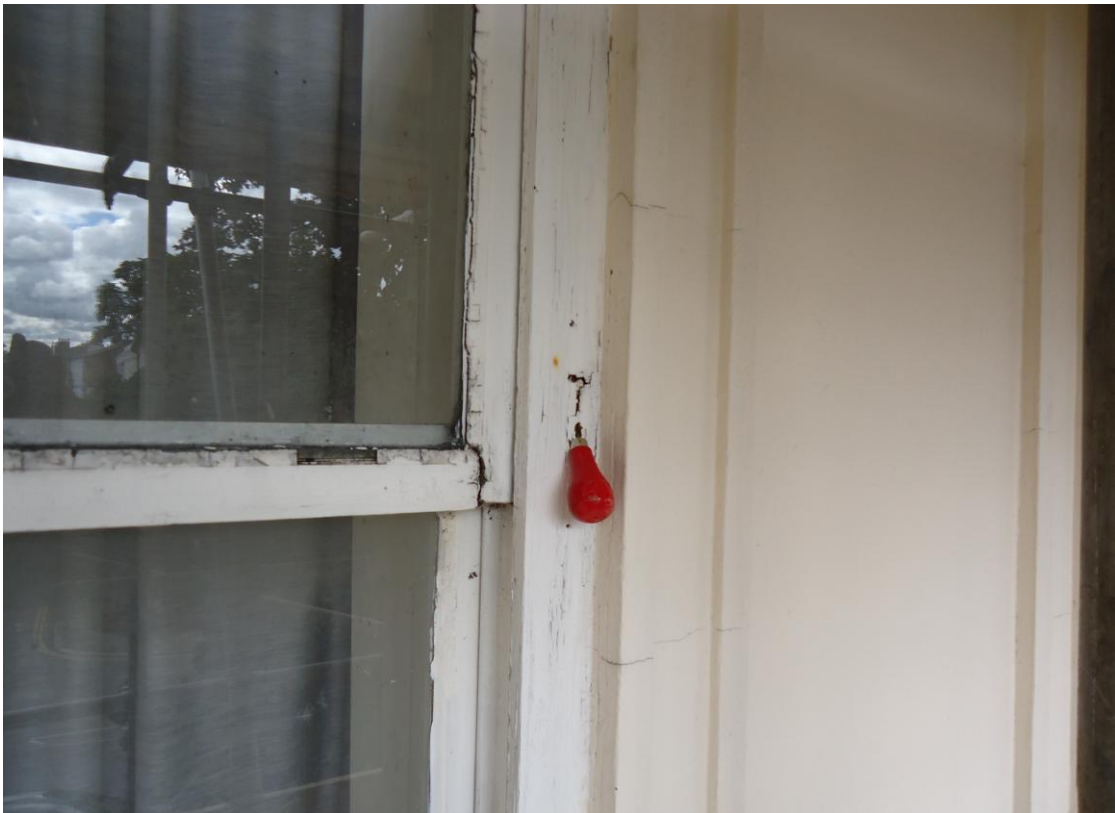
Decay to outer sash lining

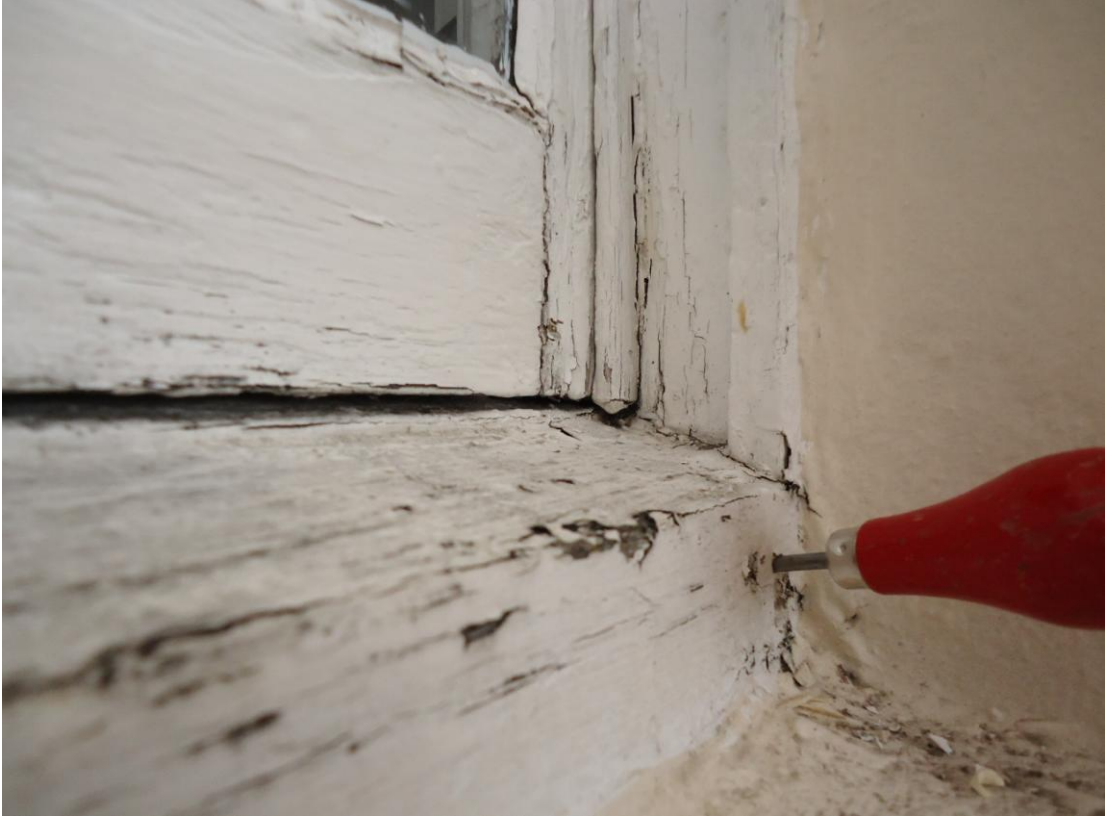
Decay to the cill, failed paint and an open sash construction joint

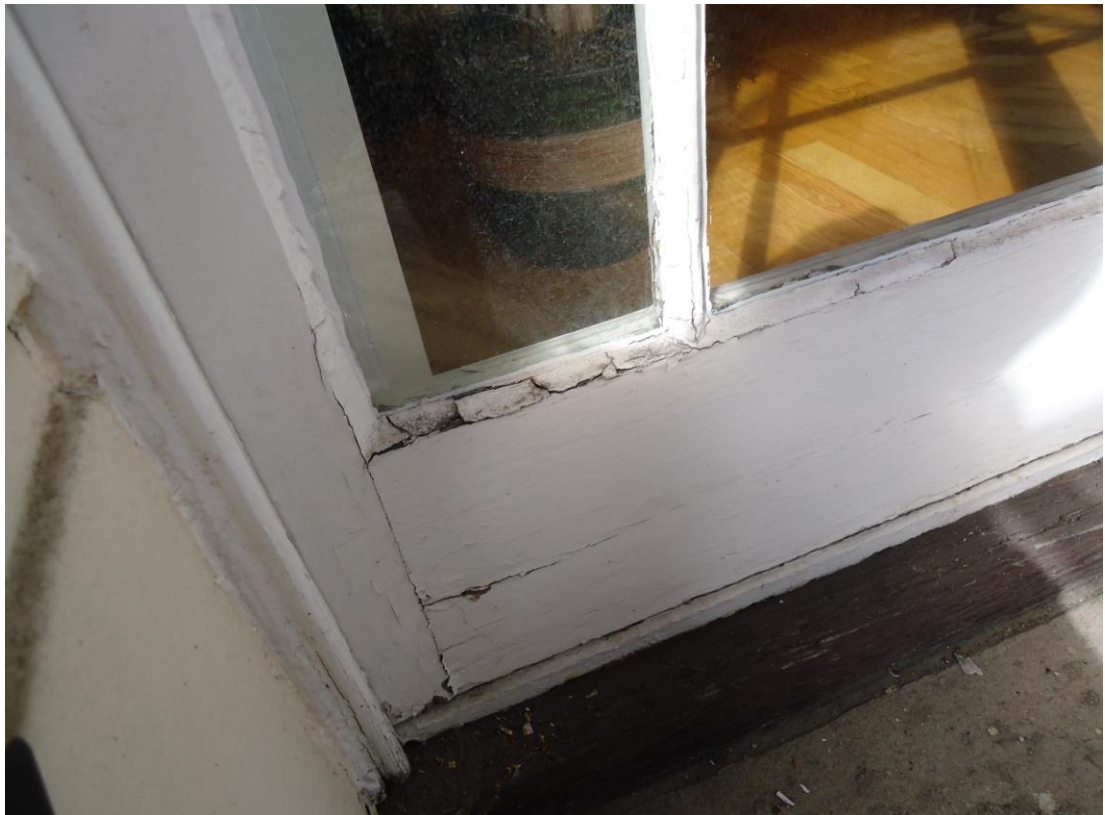
Open construction joint and horizontal split to the timber

Effectively seal all open lower construction joints in full accordance with Working Method P2 using the Repair Care Round Cutter to a depth of 10mm.

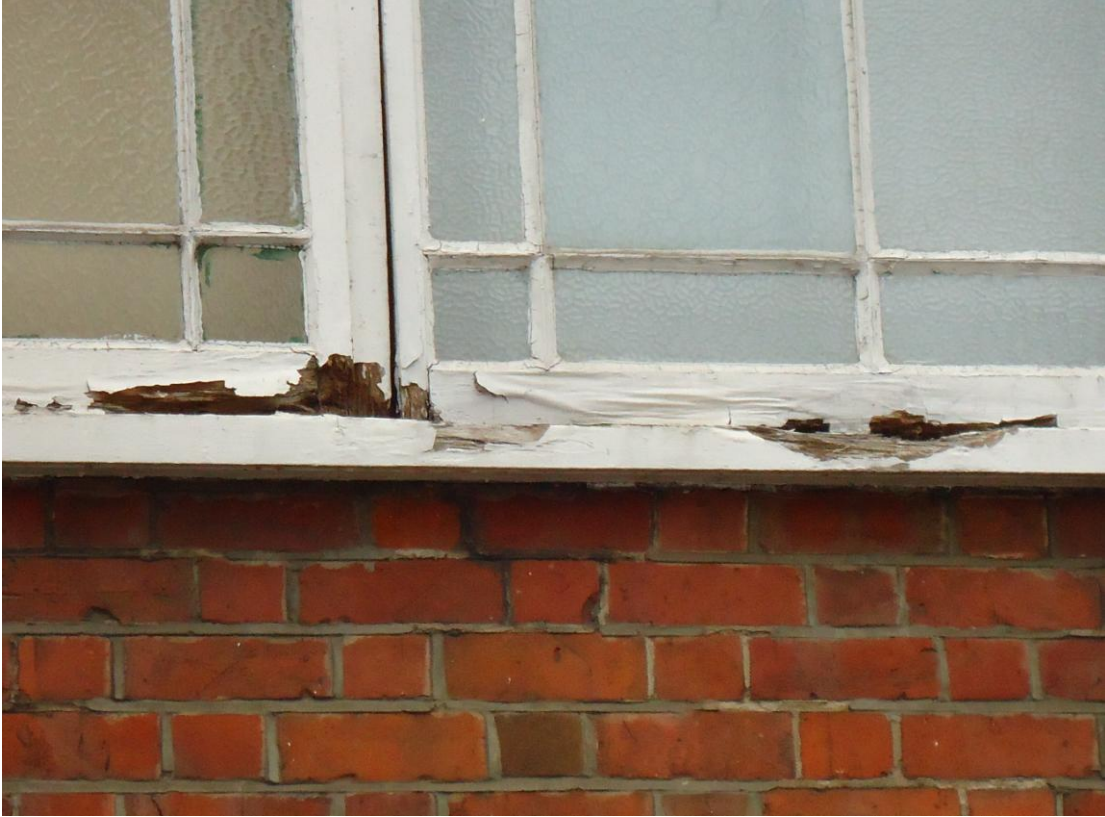
Extensive decay to East elevation covered walkway

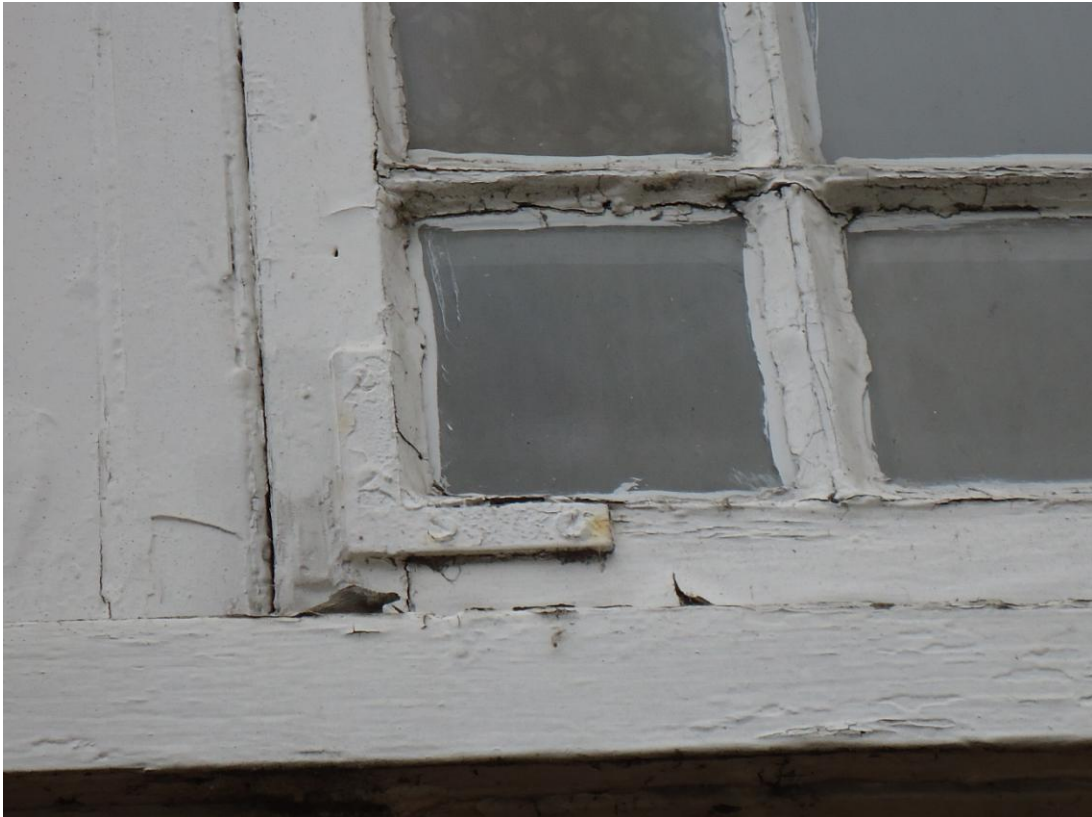
Failed putty, paint and a bracket used to repair a failed joint

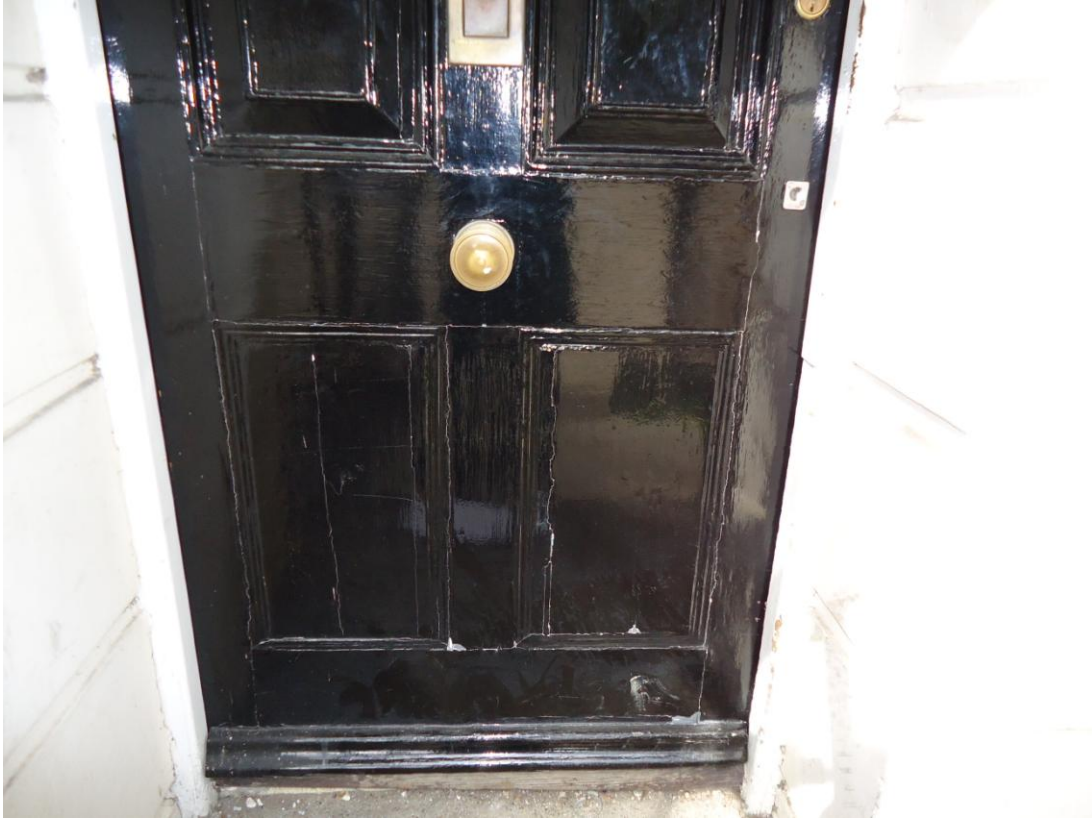
Splits in timber front doors

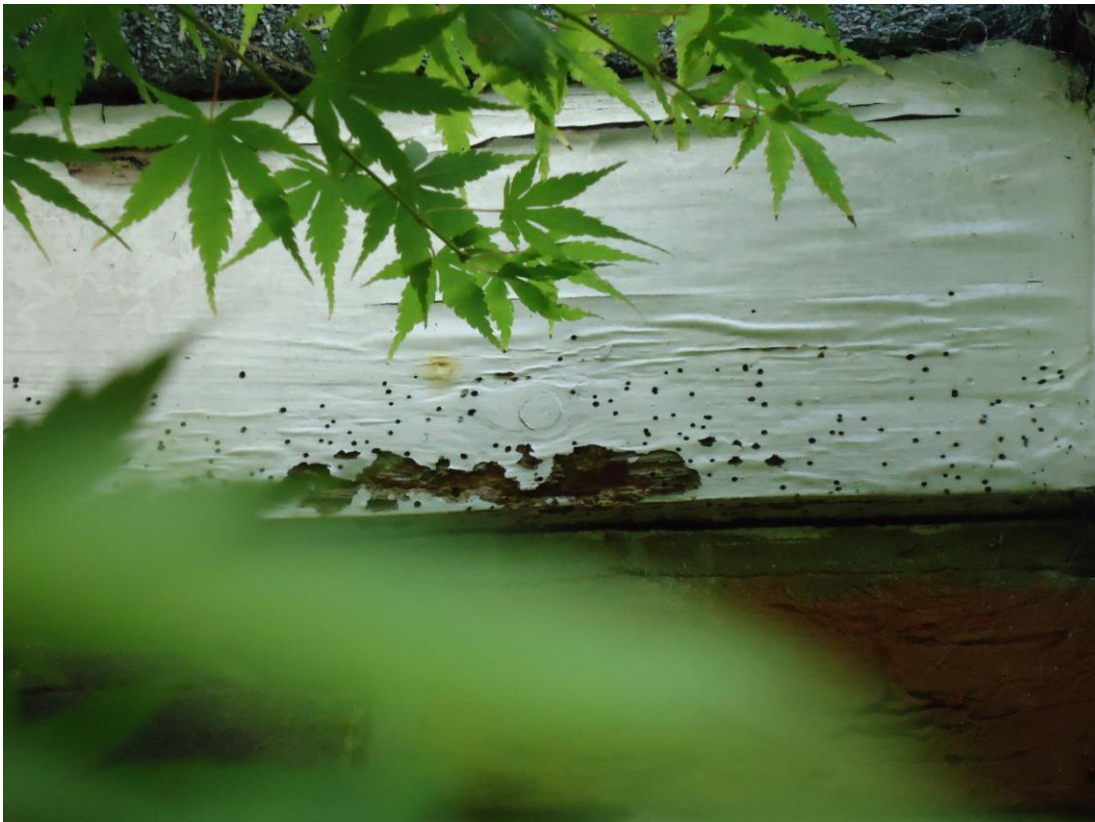
Infestation found on fascias North and West facing
